# CERTIFICATE OF LOCATION OF GOVERNMENT CORNER

NORTHEAST Corner of Section 11, Township 102 N, Range 41 W, 5th P.M.

STATE OF MINNESOTA, County of NOBLES

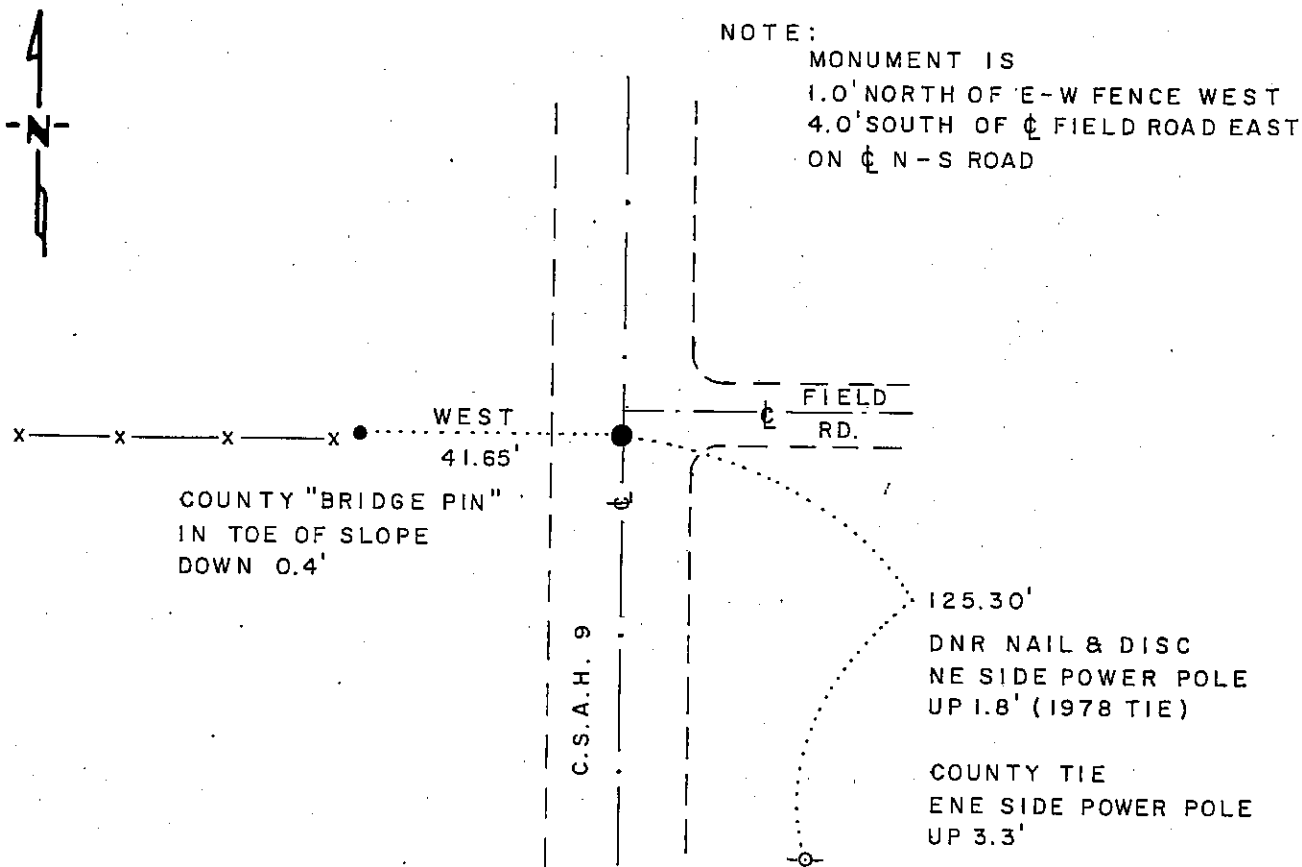
### SKETCH OF REFERENCE TIES

On 9-7-78 found a 3/8" x 12" SPIKE, DOWN 0.2'  
DATE

On 8-9-88 placed a 1 1/4" x 1 1/4" x 20" PERFORATED STEEL TUBE WITH  
DATE  
ALUMINUM CAP STAMPED "DNR SURVEY MARKER". FLUSH

NOTE:  
MONUMENT IS  
1.0' NORTH OF E-W FENCE WEST  
4.0' SOUTH OF  $\phi$  FIELD ROAD EAST  
ON  $\phi$  N-S ROAD
